Zandmotor LiDAR Survey

Field Report

Project: Zandmotor LiDAR Survey
Subject: Field Report
Author: L. Veltman MSc.
Internal reviewer: R.C. de Zeeuw MSc.
Reference: N201910-02_DLTRS_ZMLiDAR
Version: v1

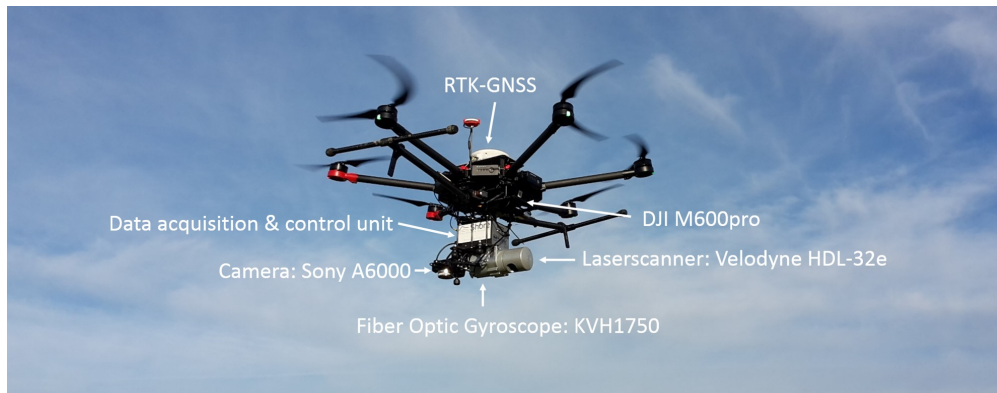
SHORE uses the AL3-32 mobile LiDAR system by Phoenix LiDAR Systems Inc. The system is usually mounted to a UAV, car or boat. Operation of the systems sensors is independent of the platform it is attached to. Figure 4.1 shows the system on an M600pro, with annotations of the different components.

Figure 4.1: Mobile LiDAR system on DJI M600pro. Components annotated.

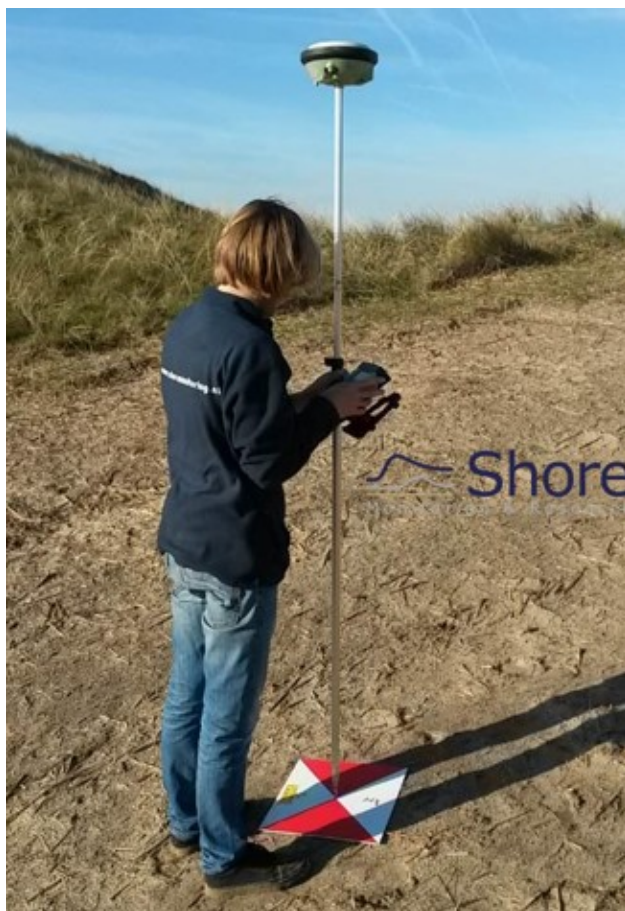
SHORE uses several Leica Viva GNSS receivers for GNSS measurements (Fig. 4.3). Manufacturers specifications are presented in Table 4.2.

Figure 4.4: Typical rover set-up

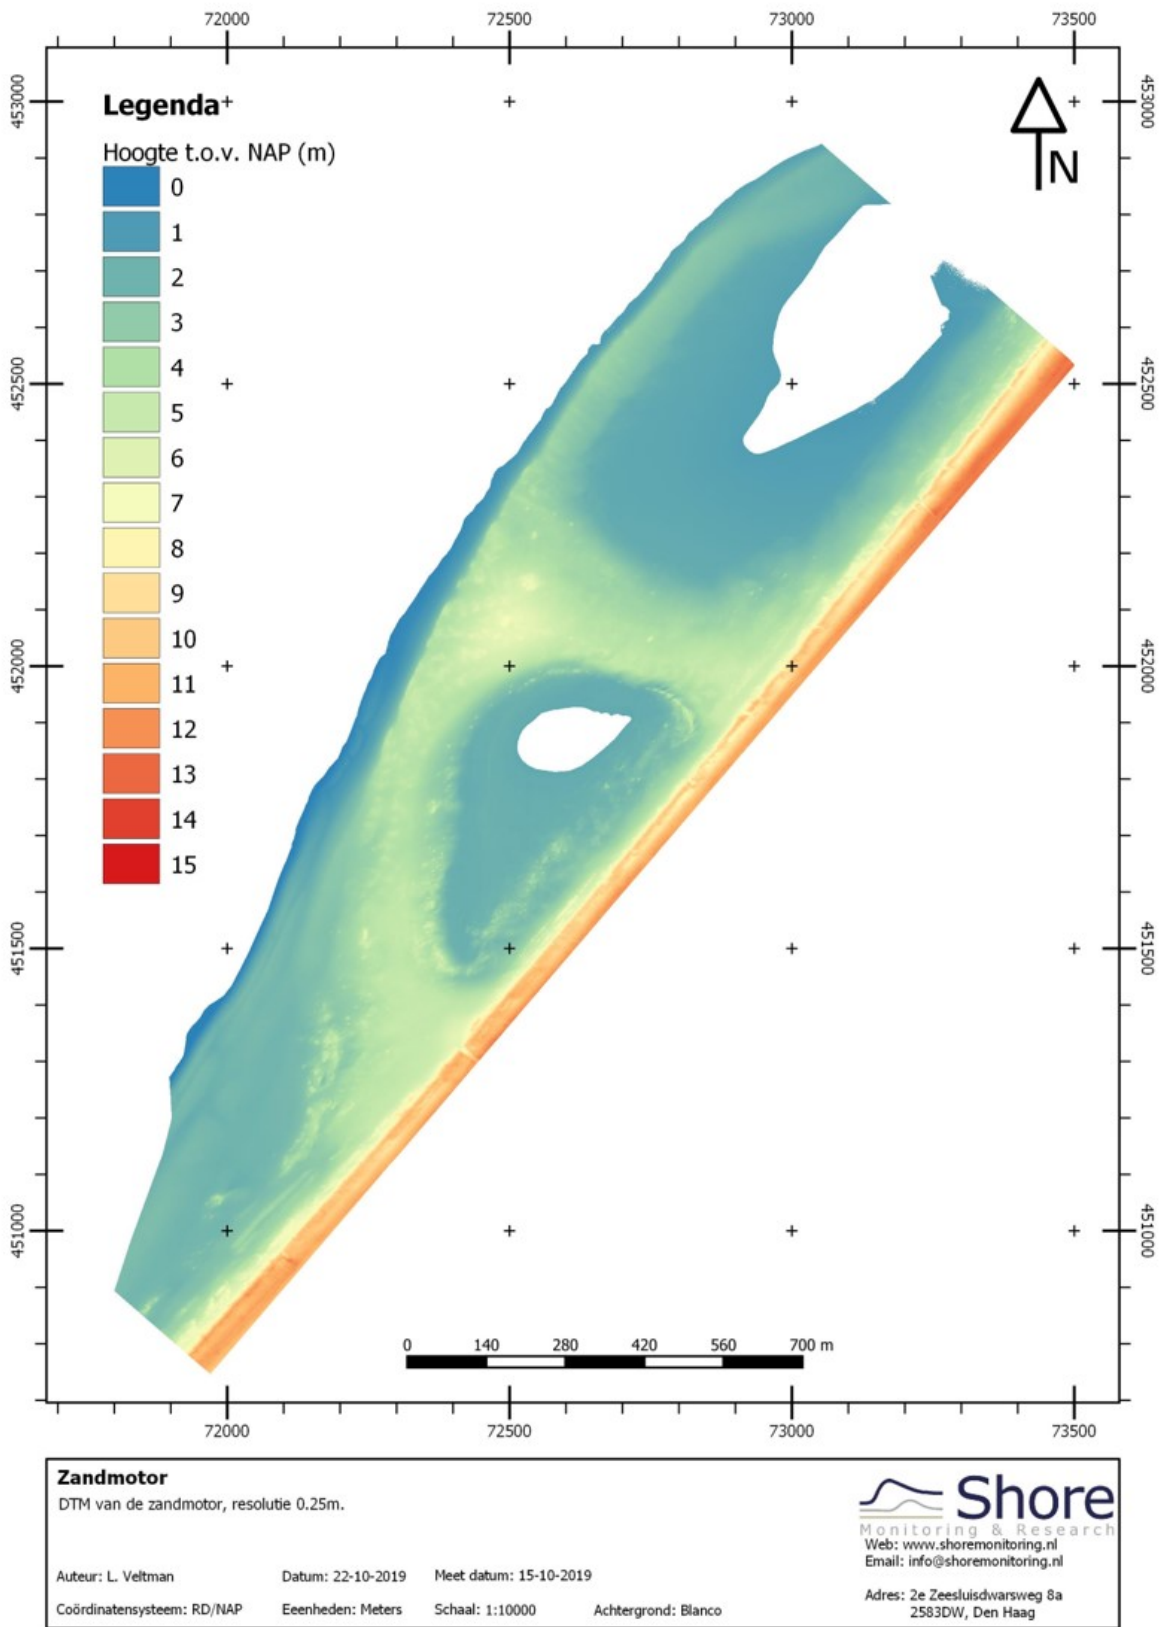
Figure 5.3: Digital Terrain Model (classification of ground points)

1. Orthophoto of the AOI, including the location of the gcps. (Fig. 5.1).
2. DSM of the AOI, including vegetation, buildings, objects etc. (Fig. 5.2).
3. DTM of the AOI, based on only ground point, so excluding vegetation, buildings, objects etc. (Fig. 5.3).

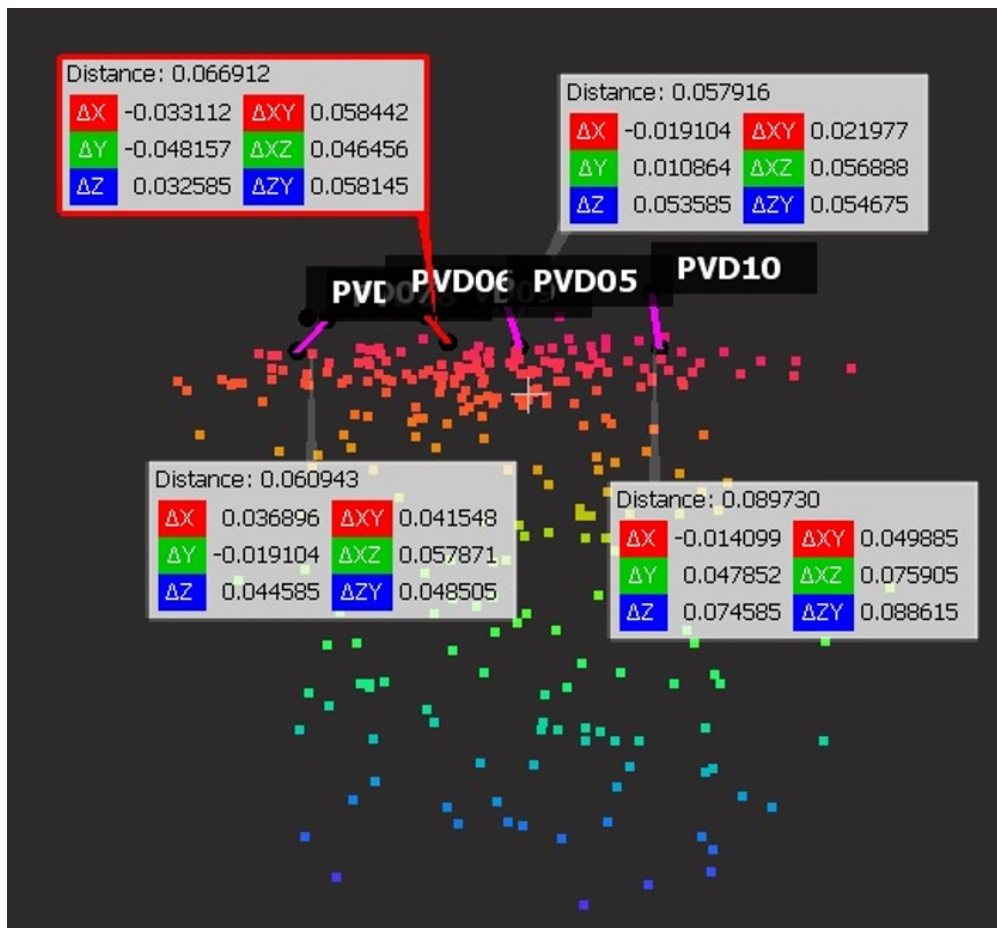
Figure 6.2: Planimetric result: GNSS and LiDAR measurement of 3D object.

- Height validation: elevation difference between DTM and GNSS measurements (Fig. 6.1)
- Planimetric validation: comparison of GNSS and LiDAR measurements of 3D objects (Fig. 6.2).

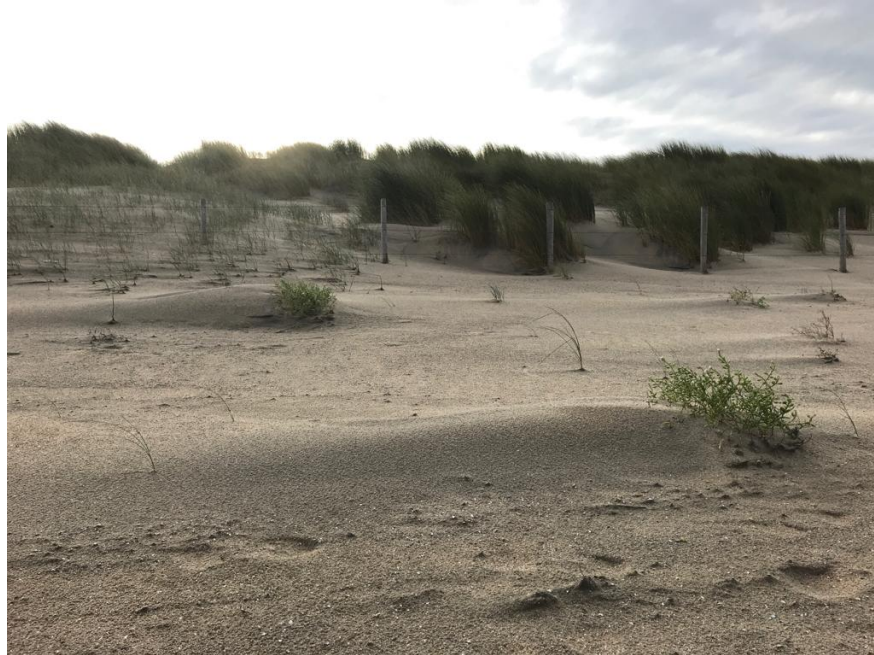
Figure 8.1: Recently developed embryo dunes. Strong autumn winds and 'sea rocket' start the creations of new sand dunes. Photo taken close to the dunelake.

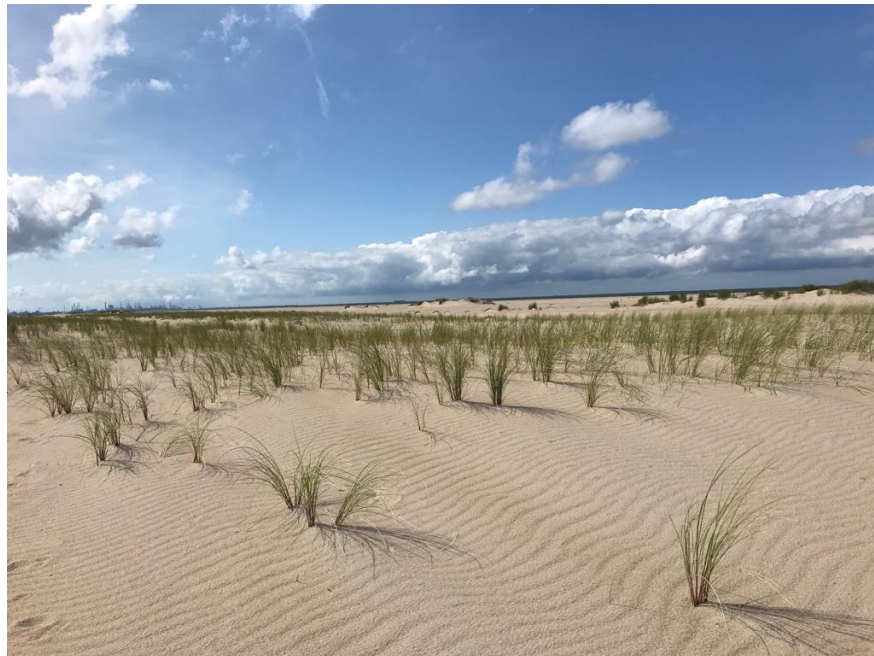
Figure 8.2: Near the southern end of the area, on the big open fields a stroke of 'beach grass' is visible. Surrounded by car tracks, the new vegetation still manages to survive.
